# Construction Biodiversity Management Sub-Plan

N228

Moore Park Precinct Village and Carpark

22 April 2025

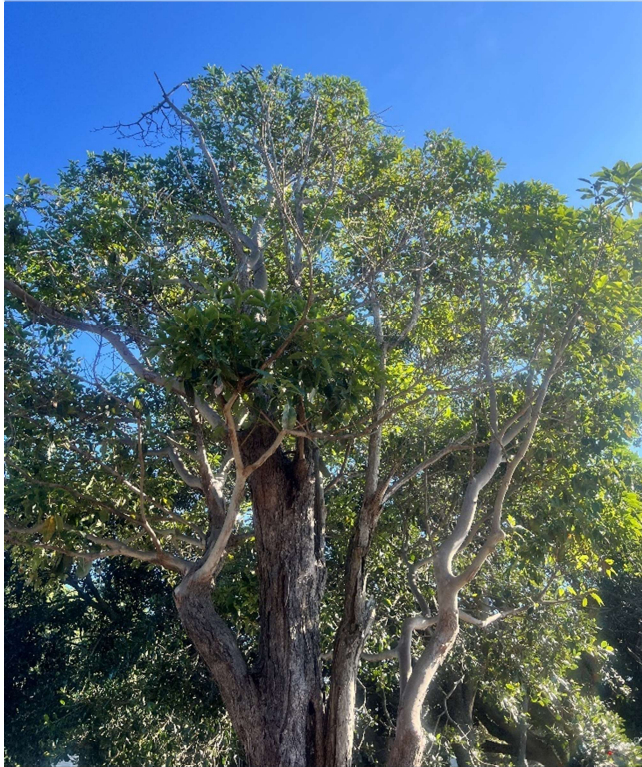
It is understood a tree removal application is pending for Trees 173 and 175. Tree 173 is in poor health and Tree 175 is in fair health. Both trees have a reduced crown density of 50-75% and the presence of extensive deadwood within their crowns. The crown of Tree 173 has also been recently exposed by the removal of Tree 147 in 2023. Both trees are in poor structural condition. Tree 173 has a significant trunk wound from ground level to approximately 2m in height. This wound is extensively decayed and is developing into a trunk cavity. Tree 175 has a trunk/basal cavity with significant decay developing in the root crown and structural roots. These defects are considered significant, and as a result, the trees have an increased likelihood of failure, particularly during rain, wind or severed weather.

**Figure 1: Showing crown of Tree 173**

Additionally, clarification has been sought regarding the removal of Trees 173 and 175. TreeiQ previously provided a detailed report on these trees. Tree 173 was assessed as being in poor health, while Tree 175 was in fair health. Structurally, both trees were found to be in poor condition. Given the severity of these defects, both trees were recommended for removal. A copy of this report has been attached.

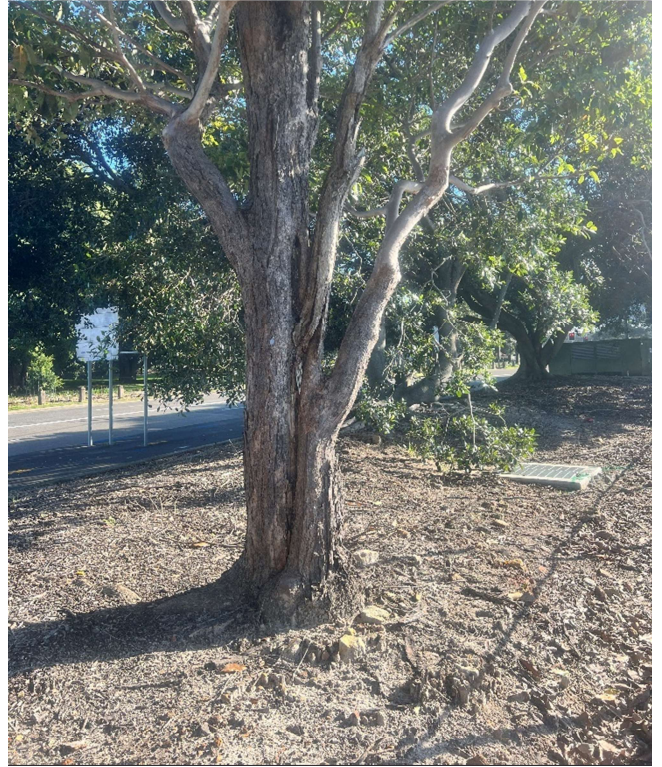
**Figure 2: Showing trunk wound on Tree 173**

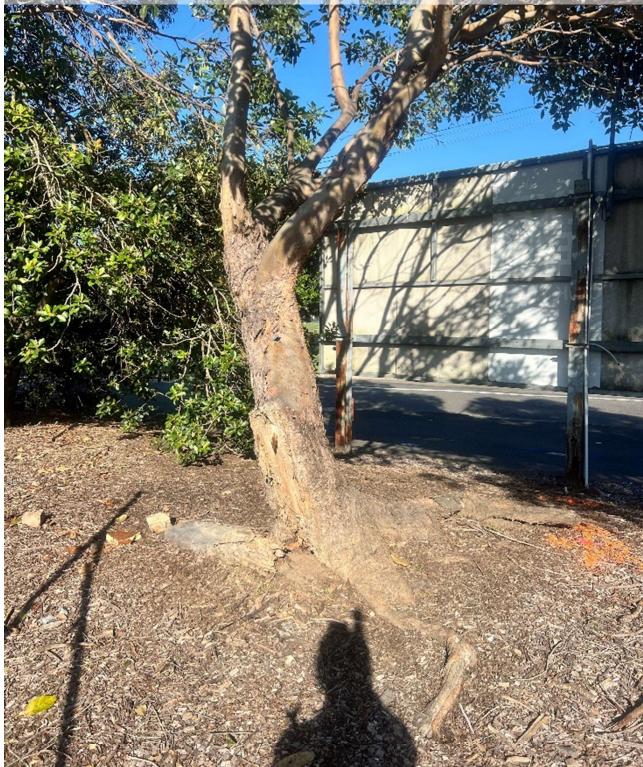
**Figure 3: Showing basal cavity of Tree 175**
