Construction Heritage Management Plan

Sydney Football Stadium

Stage 3 Moore Park Precinct Village
and Car Park

Prepared for BESIX Watpac
August 2024

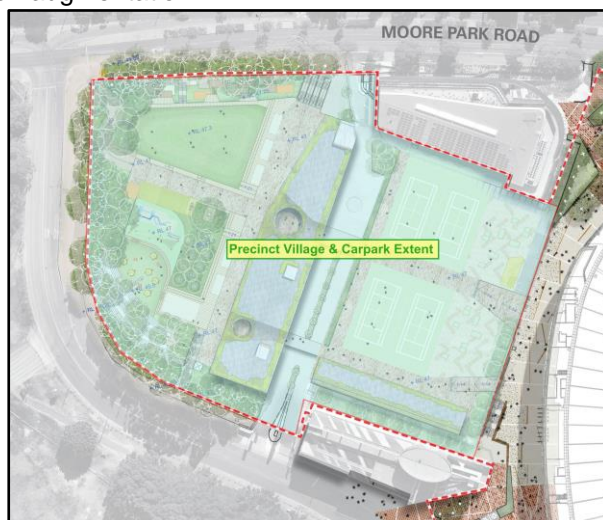
Figure 1: Proposed design of the SFS PV&C (Source John Holland)

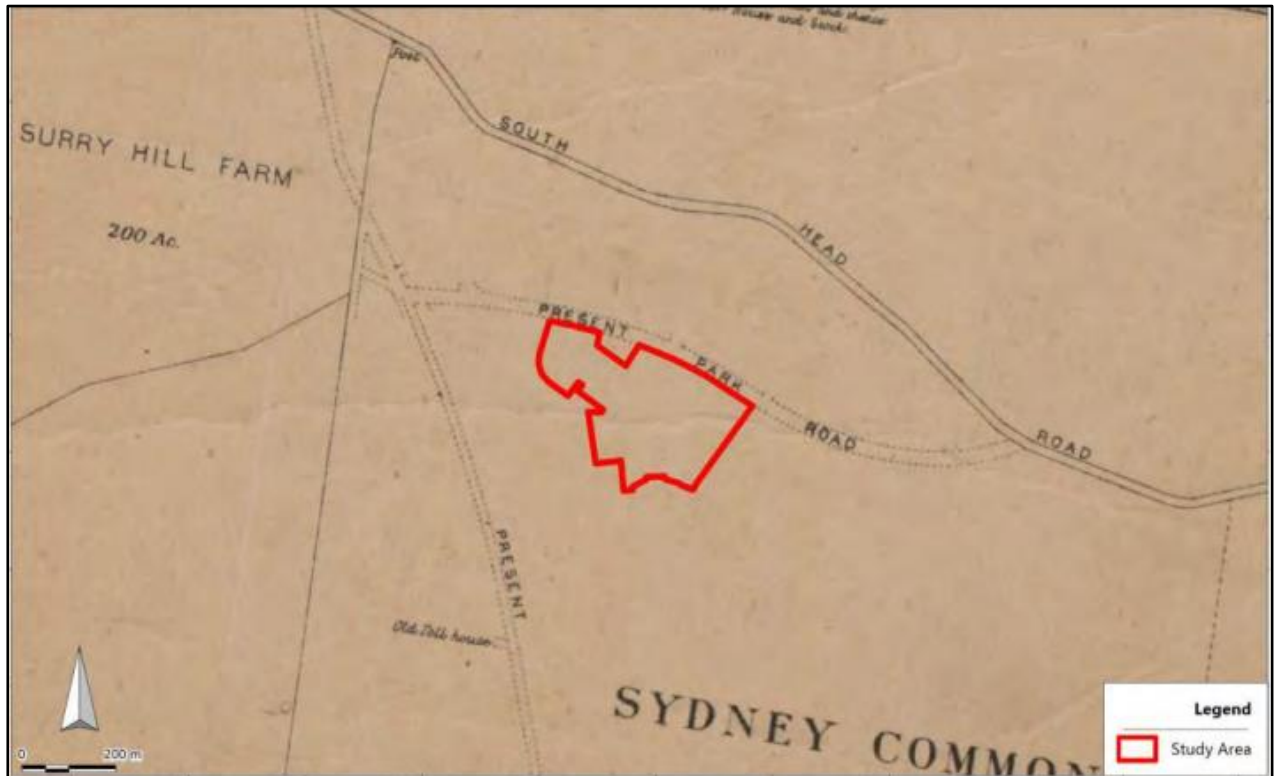
Figure 3: Map of the Sydney Common, 1811 (with study area in red). Source: NLA via Curio Projects

In 1811 Governor Macquarie dedicated a 1000-acre parcel of land, containing the subject site, for public recreational use. This area became known as the Sydney Common and was established in order to discourage people from grazing their animals in other public reserves such as Hyde Park (Figure 3).¹² The eastern portion of the Common was swampland which was declared as a freshwater reserve in the 1820s and now includes much of Centennial Park.

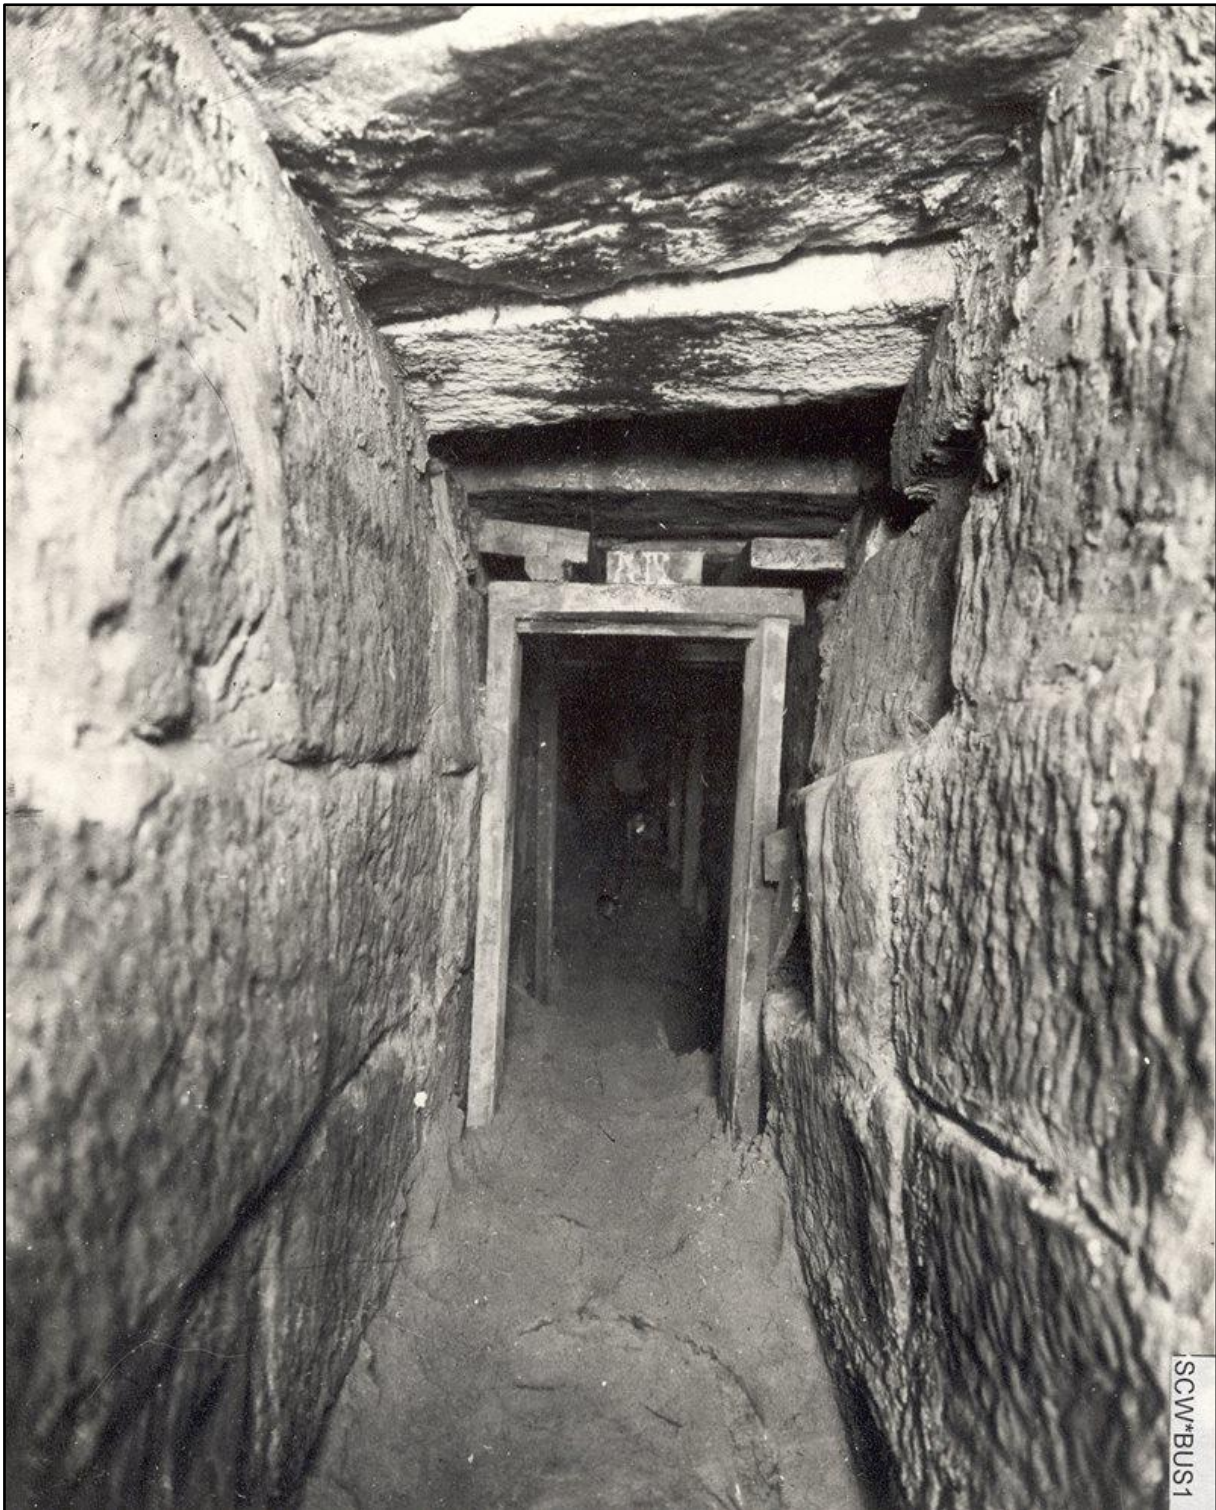
Figure 8: Busby's Bore at the intersection of College and Liverpool Streets, constructed with stone masonry lining. Source: Sydney Water Archives. Note: This type of construction was not used in the construction of the Busbys Bore Spur

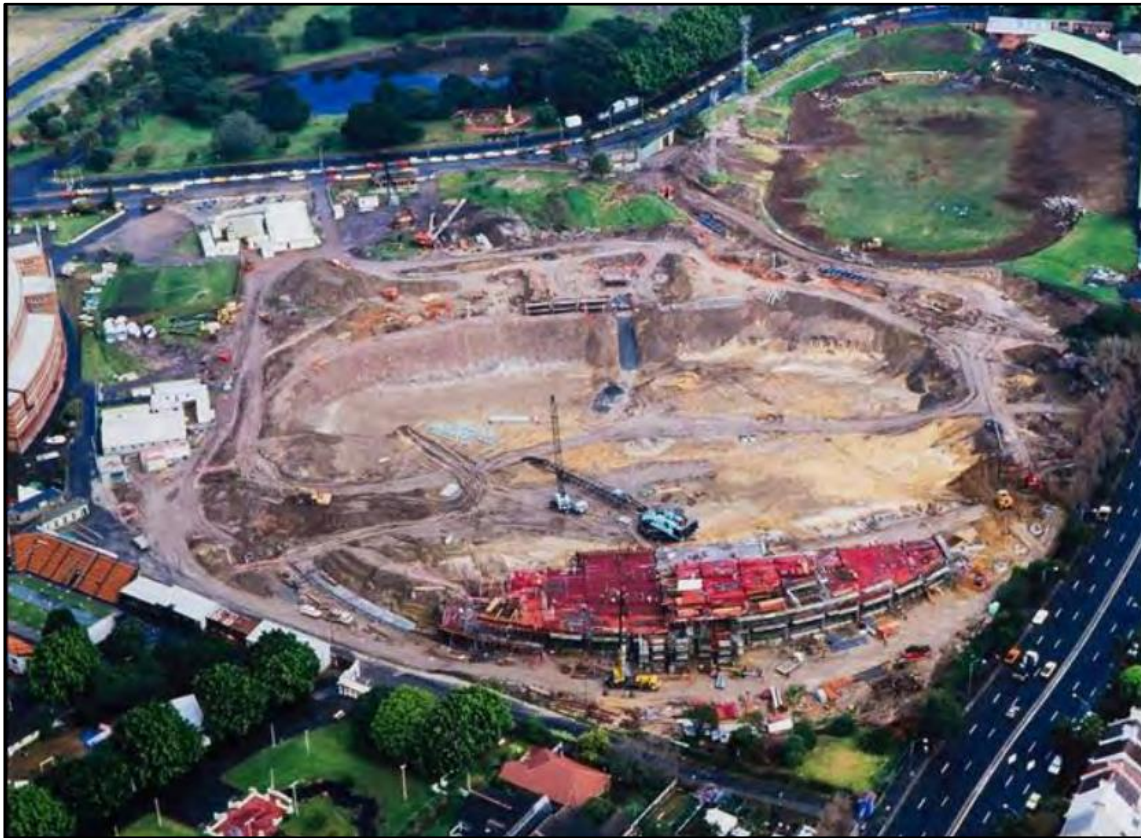
Figure 18: Construction of the SFS, 1987. Source: Sydney Cricket Ground Museum⁵²

An architectural competition for the design of the SFS was announced, with the successful design by the architecture firm Phillip Cox Richardson Taylor, with Ove Arup & Partners as engineers. The construction of the stadium required the demolition of the SSG, the military depot, and the levelling of Oval 2 of the SCG (Figure 18). The stadium was designed to minimise noise and light impacts to nearby residential areas and Cox's design featured a warped oval roof which prevented shading the playing field.⁴⁹ The stadium had a capacity of 40,000 people and was opened in January 1988 (Figure 19).

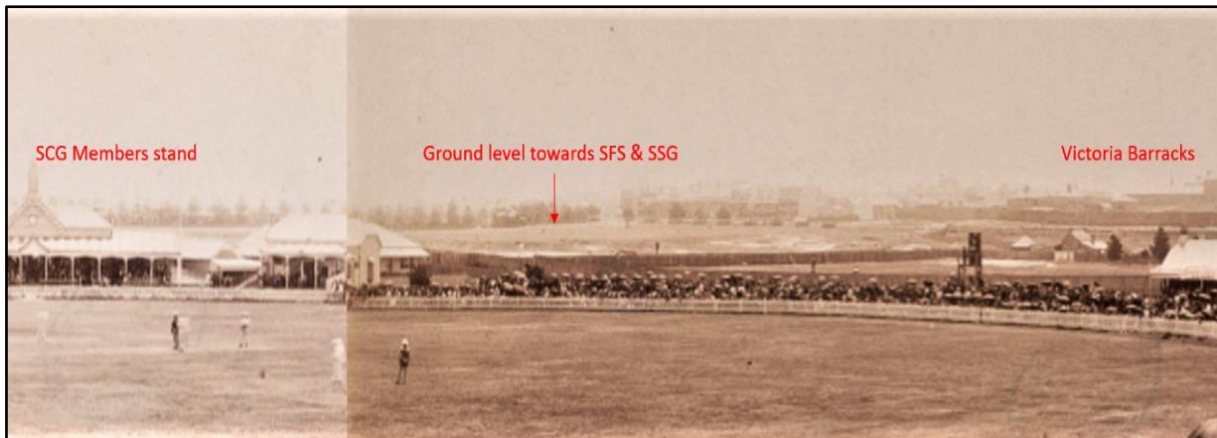
Figure 22: Cricket match at the SCG 27/1/1919. View north west (Trove NLA)

In 1875 works commenced to form the Sydney Cricket Ground.⁵⁴ A photograph of a cricket test match played at the Sydney Cricket Ground in 1883 shows the future location of the former SFS in the background as a raised piece of land, rising upwards to the north west. Two historical photographs from the same day (27 January 1883) have been spliced to create (Figure 22). The Sydney Cricket Ground Members stand, and the Victoria Barracks remain in situ today, allowing for a definite identification of the SFS future location from this photograph. The row of conifer trees in the background of Figure 22 is almost certainly the row of trees shown eight years earlier in as juvenile plantings along Anzac Parade.

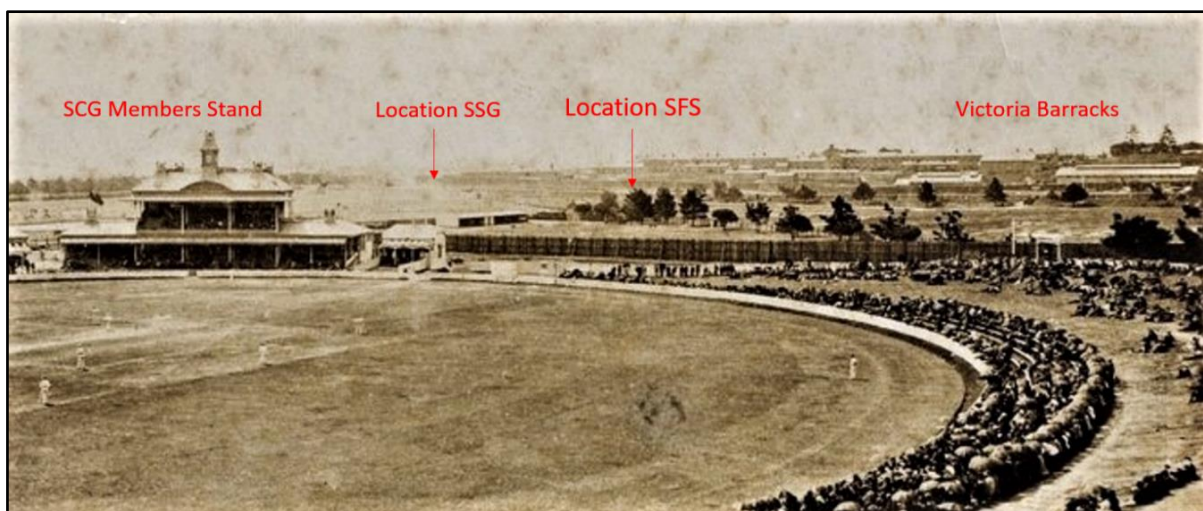
A photograph of another cricket match played nine years later in 1892 looks slightly more to the west (Figure 23) and is taken from a higher elevation. This image shows the raised ground of the where the former SFS would be located and SSG, and also illustrates that the Sydney Cricket Ground was likely cut significantly into local dunes to produce banked or bowl like sides as seating.

Figure 23: Cricket match at the SCG in 1892. View west north west (Trove NLA)

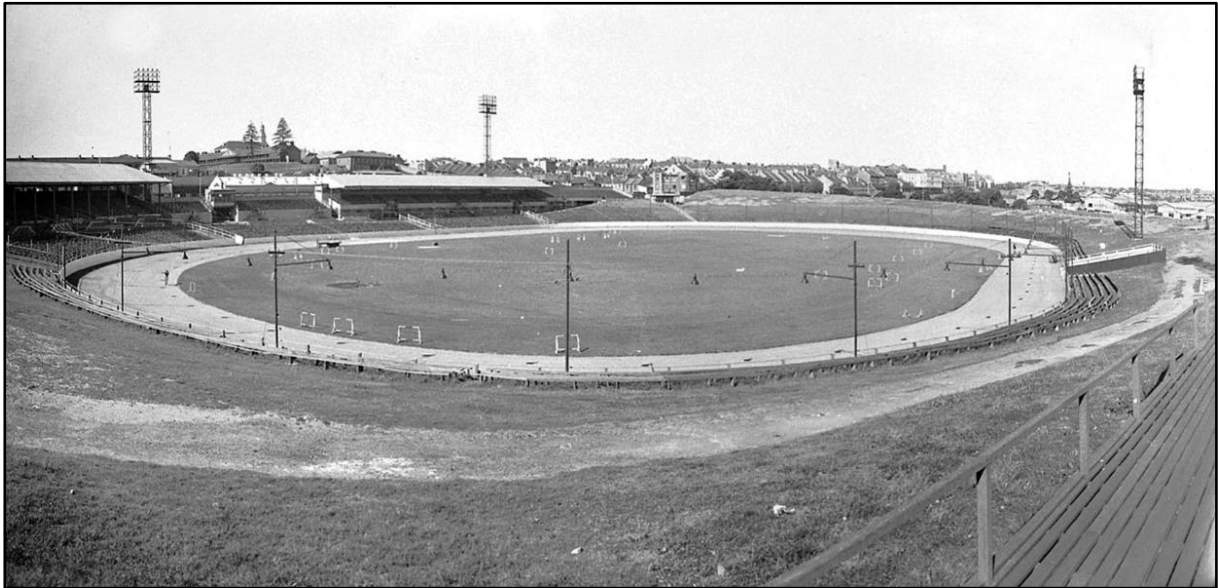
Figure 24: SSG in 1937. View north east (Trove NLA)

This proven technique of excavating a flat playing surface into surrounding dunes appears almost certain to have been followed in construction of the SSG located to the north east of the Sydney Cricket Ground and partly within the footprint of the SFS Redevelopment. Dedicated in 1899, the SSG was opened in 1903. It had been excavated to depth below the surrounding landscape and was formed with high banked earthen sides to provide both informal seating and a facility for motorcycle racing (Figure 24).⁵⁵ The depth of excavation carried out to create this sunken bowl is estimated as at least five to six metres, based on the likely height of the two-storey stadium grandstand visible in Figure 24 which does not appear significantly taller than the surrounding earthen stadium walls.

Aerial imaging of works in 1986 for the former SFS show levelling and filling and in particular, reduction of the banked walls between the former SFS, the SSG, and the oval to the south west of the former SFS (Figure 24).

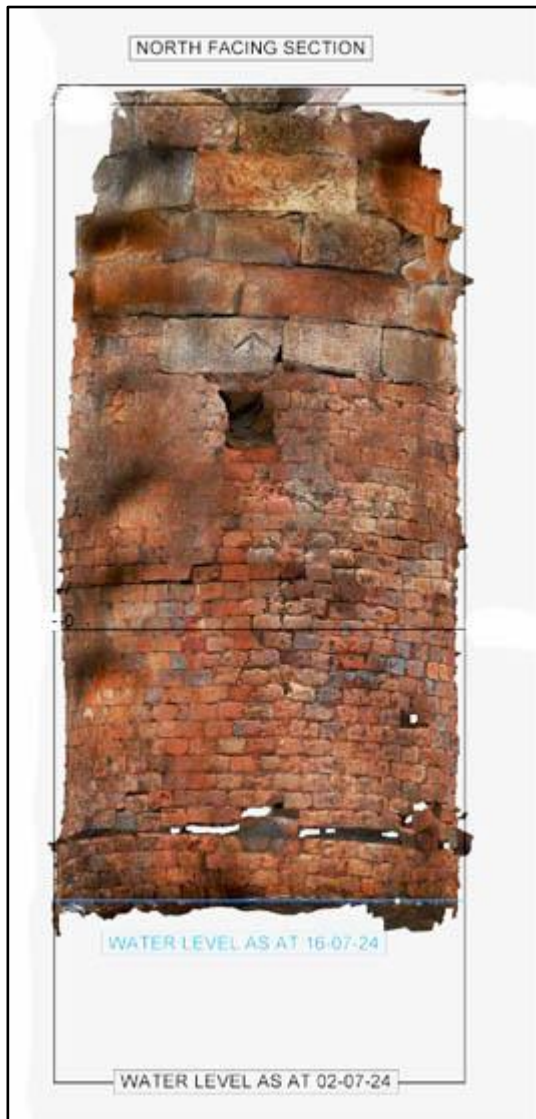
Figure 32: North elevation of BBS-1

The top of the shaft was constructed as four layers of dressed sandstone block (0.88m or 2.9ft). One of the blocks has a crude broad arrow on it. This symbol was used to mark Government property.

The remains of the shaft was constructed by 33 rows of sandstock bricks (2.28m or 9.45ft). It is presumed that these extend into the water or until the underlying sandstone has been reached. The underwater CCTV evidence is that the base of the shaft is constructed in sandstone with some underwater evidence of bricks. The brickwork is in fair condition although there is a section of collapse visible on the north elevation.
