Construction Heritage Management Plan

Sydney Football Stadium

Stage 3 SSD 9835 Moore Park
Precinct Village and Car Park

Construction Heritage Management Plan
Sydney Football Stadium Redevelopment Stage 3 SSD 9835
Moore Park Precinct Village and Car Park

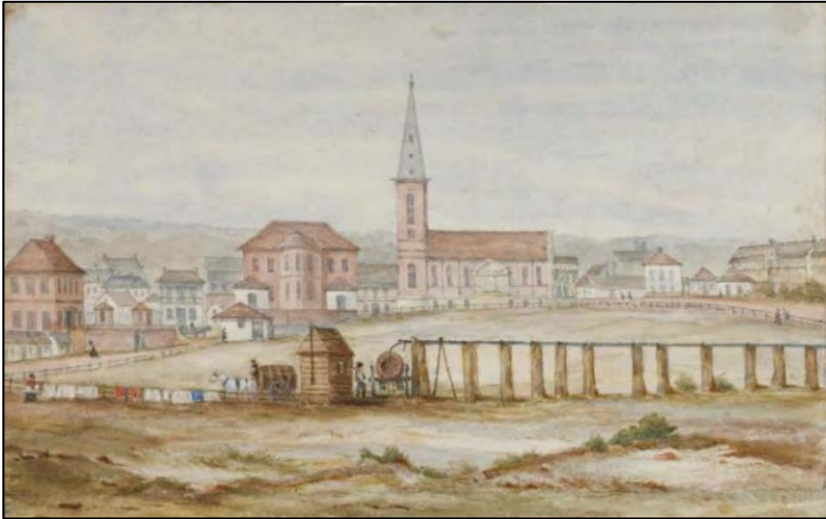
Figure 6: Busby's Bore piping at Hyde Park (looking north with St James Church in the background), n.d. Source: City of Sydney Archives

The works were completed in May 1837 and the water was piped across Hyde Park to the corner of Elizabeth and Park Streets on a timber viaduct (Figure 6). Here (at the current location of Museum Station), the water from Centennial Park was collected and transported throughout Sydney via horse and cart. There was no grant opening for the scheme. Judging from newspaper reports as the tunnel progressed water flowed down to Hyde Park and various institutions tapped into it via pipes.²⁶ Thus water started being supplied before the tunnel reached the swamps.

The tunnel works were completed in 1837 and the water was piped across Hyde Park to the corner of Elizabeth and Park Streets with above-ground trestles (Figure 6). Here (at the current location of Museum Station), the water from Centennial Park was collected and transported throughout Sydney via horse and cart. Upon the establishment of Sydney's first water pipe system in the 1840s, the pipes were connected to the Bore system and the fresh drinking water was distributed throughout the city automatically.³⁵ Along the route of the tunnel, 28 wells have been located to date ([Figure 8](#)[Figure](#)

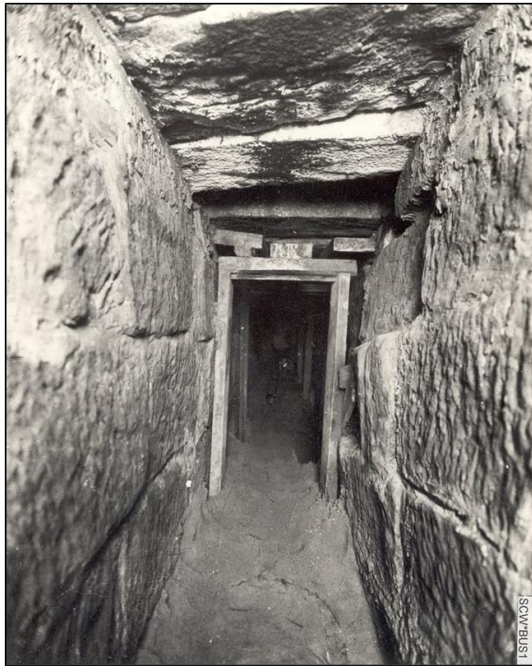
Figure 7: Busby's Bore at the intersection of College and Liverpool Streets, constructed with stone masonry lining. Source: Sydney Water Archives. Note: This type of construction was not used in the construction of the Busby's Bore Spur.

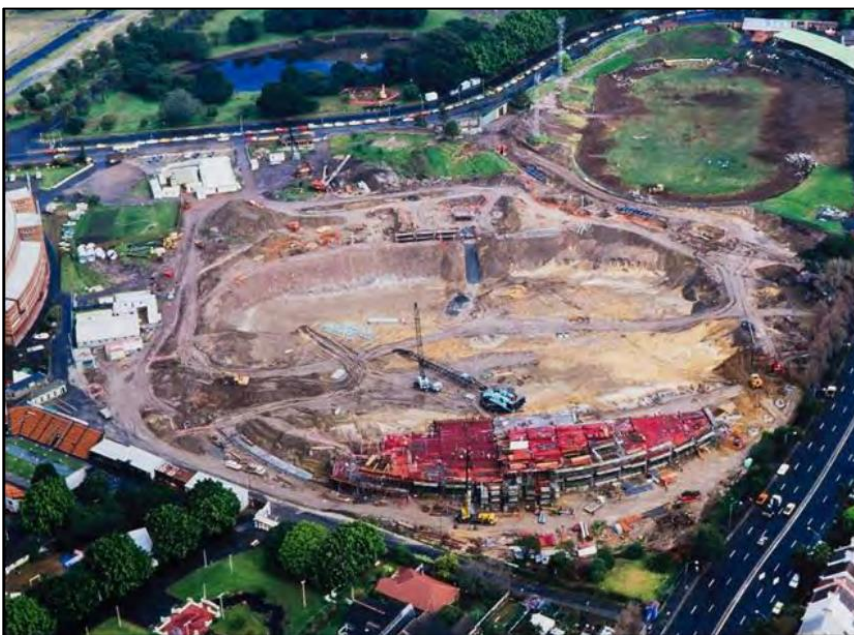
Figure 9: Construction of the SFS, 1987. Source: Sydney Cricket Ground Museum⁵³

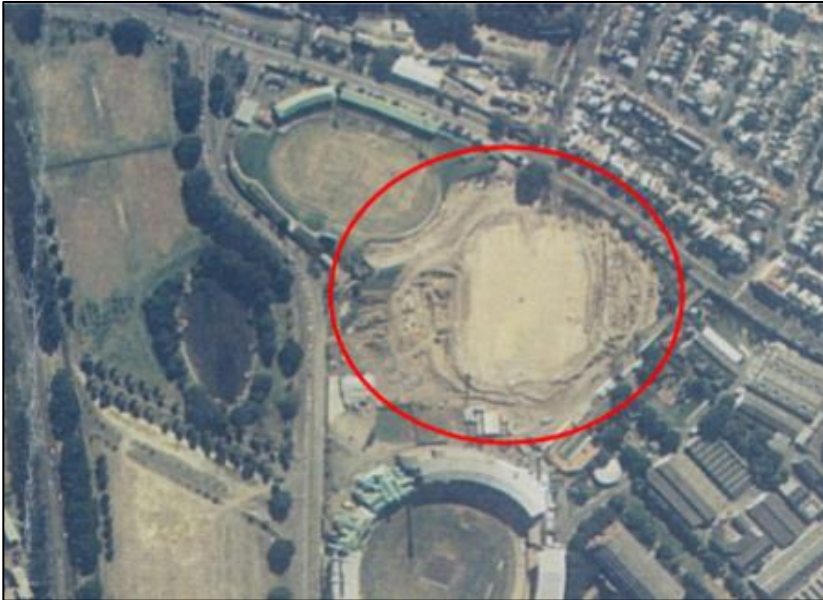
Figure 14: Project area in 1986 (Douglas Partners 2019)

Aerial imaging of works in 1986 for the former SFS show levelling and filling and in particular, reduction of the banked walls between the former SFS, the SSG, and the oval to the south west of the former SFS (Figure 9). It is likely that the current car park was constructed at that time further covering the top of BBS-1

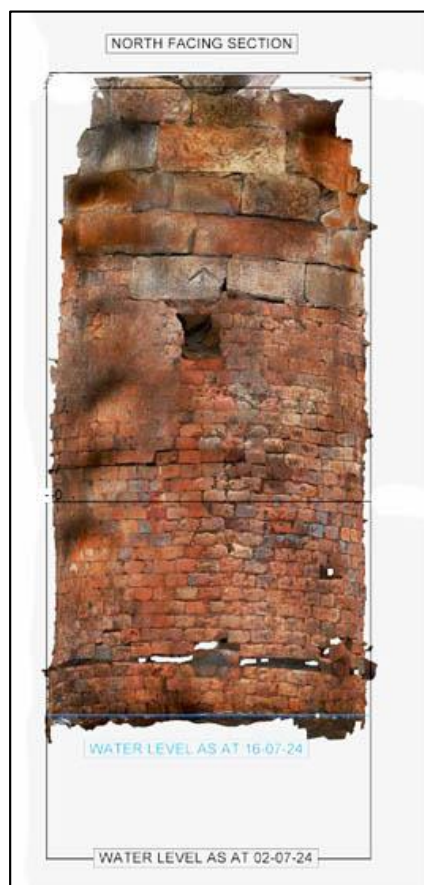
Figure 17: North elevation of BBS-1

The shaft above the water was recorded by photogrammetry by Guy Hazell (see Figure 16, Figure 17 and Figure 18).

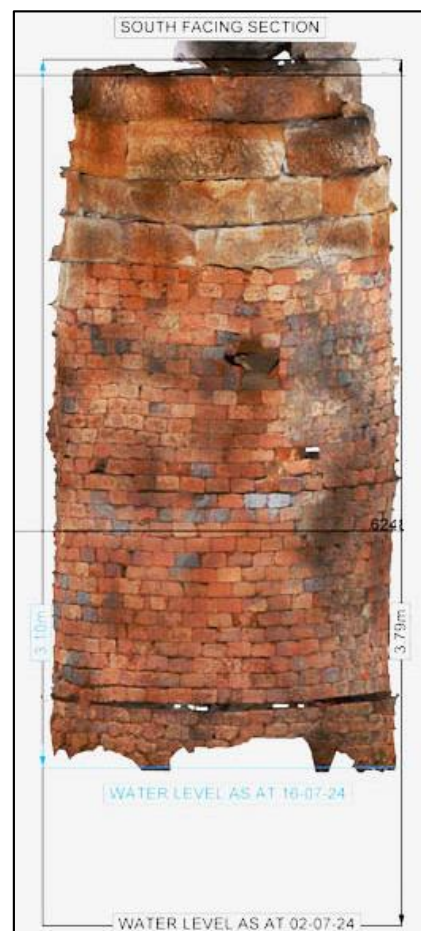
Figure 18: South elevation BBS-1

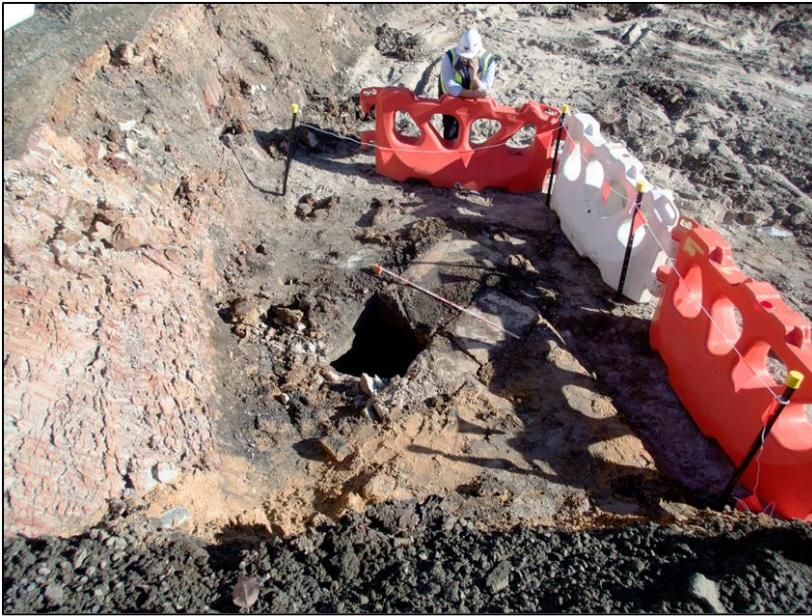
Figure 19: Top of BBS 1 looking west

The location of the find identified in this report as Busby's Bore abandoned sSpur Shaft 1 (BBS 1) can be seen in ~~Figure 19~~ [Figure 19](#) ~~Figure 20~~.

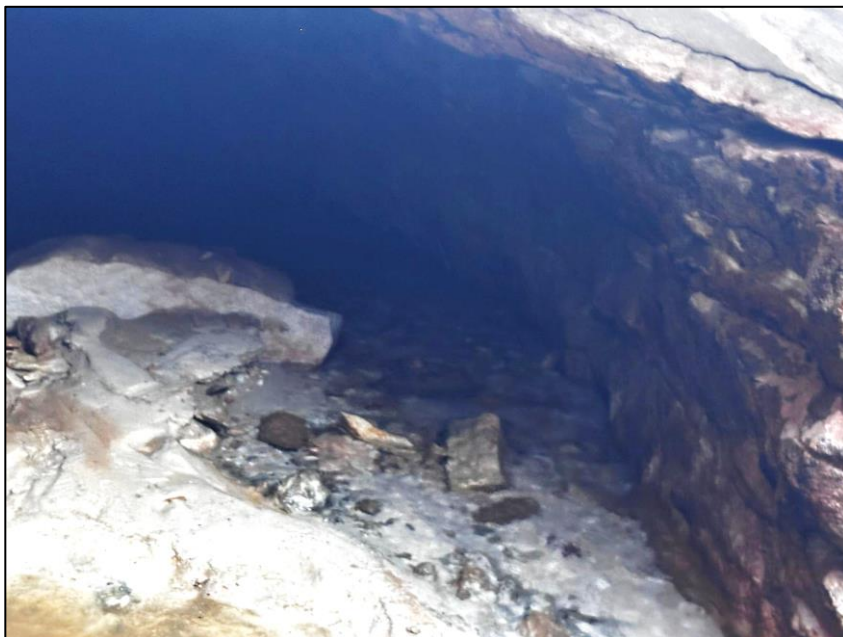
Figure 21: Photogrammetric plan of the top of the well

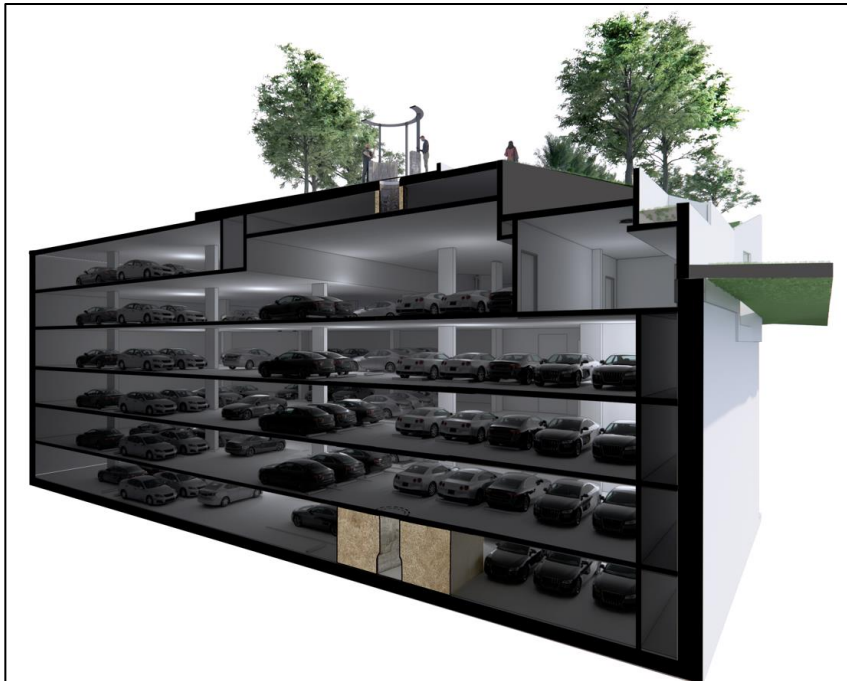
Figure 2122: Section of the proposed car park showing remains and interpretation of BBS-1 (source Venues NSW)

The section of the shaft that is to be removed will be undertaken by stone masons under archaeological supervision to the level of Car Park B4. The proposed outcome is shown in ~~Figure 21~~ ~~Figure Figure 22~~ and ~~Figure 22~~ ~~Figure Figure 23~~. Details of the removal and archaeological monitoring are discussed below.

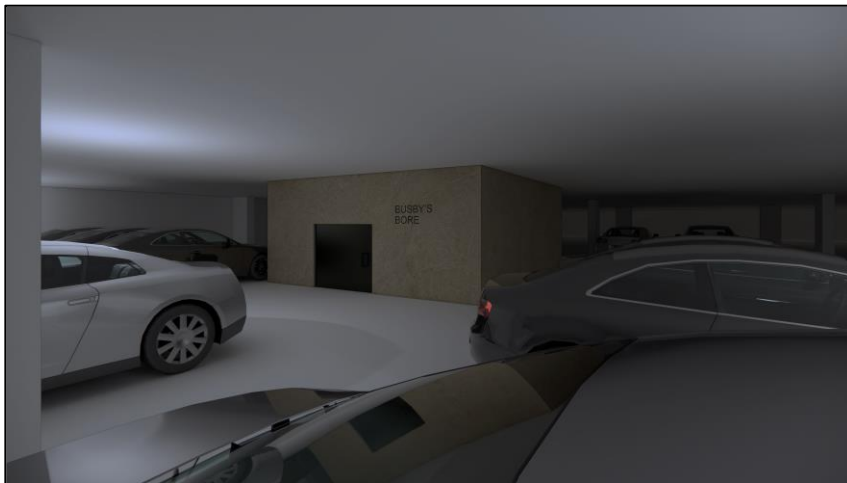
Figure 2223: Level B4 with remains of Shaft BBS-1 (source Venues NSW)
